SERVICE BULLETIN: JSB 041-1

Issue: 1
Release Date: 13th July 2017
Effective Date: 20th July 2017
Subject: Jabiru Elevator Cable

Affected Models: All aircraft

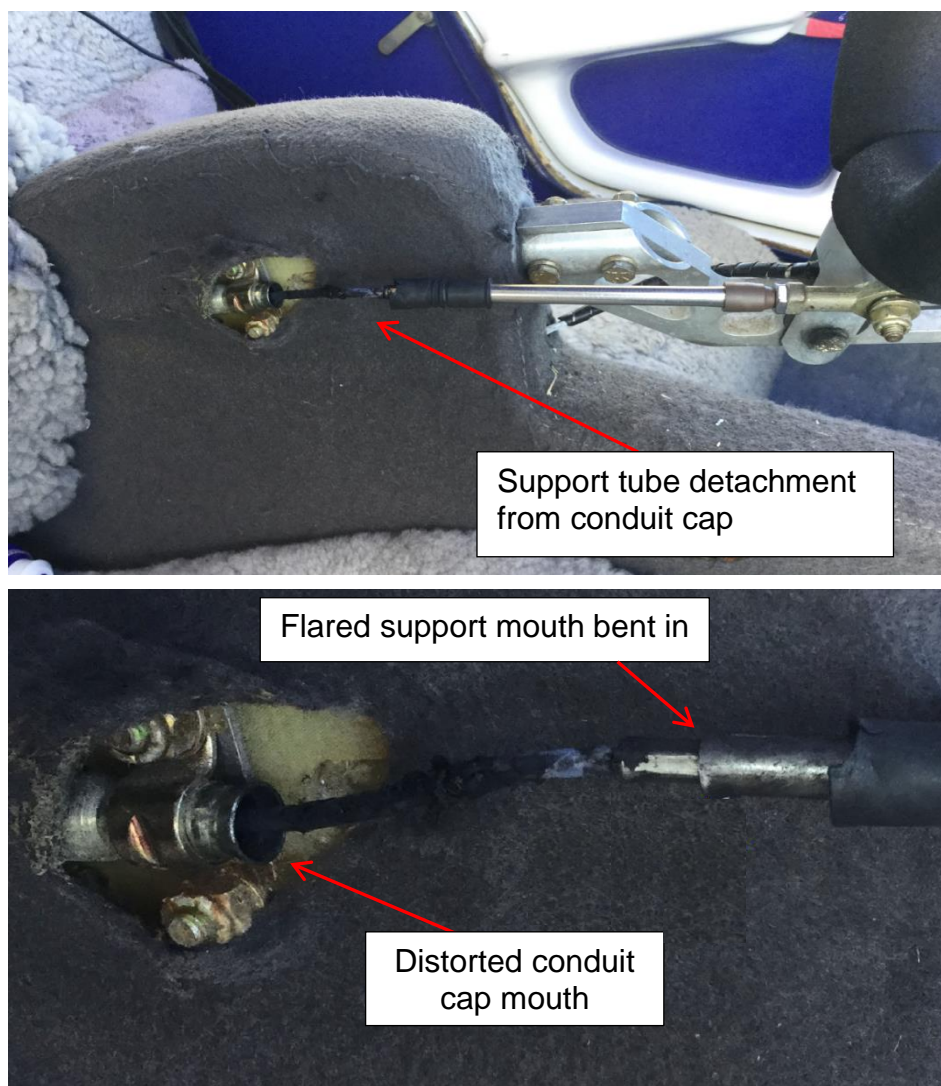
Figure 2 – Cable failure

- An attachment defect at 1600 hours TTIS was brought to the attention of Jabiru Aircraft whereby the conduit cap and support tube had become distorted (non-circular) at their ends. In a certain control stick position, this caused the support tube to detach from the

conduit cap, exposing the cable (inner member) itself. With no support tube, the cable was unable to slide back smoothly through the conduit, subsequently inhibiting back pressure (pitch up manoeuvres) to be applied from the control stick. Figure 2 shows the exposed cable with distorted tube mouths which allowed for the detachment to occur.

If it is found that the mouth of the conduit cap is significantly distorted and non-circular or that the support tube detaches from the conduit cap joint, the condition must be corrected **before further flight**. Contact Jabiru Aircraft if this situation is encountered and complete a Continued Operating Safety Reporting Form that can be found at the following web address:

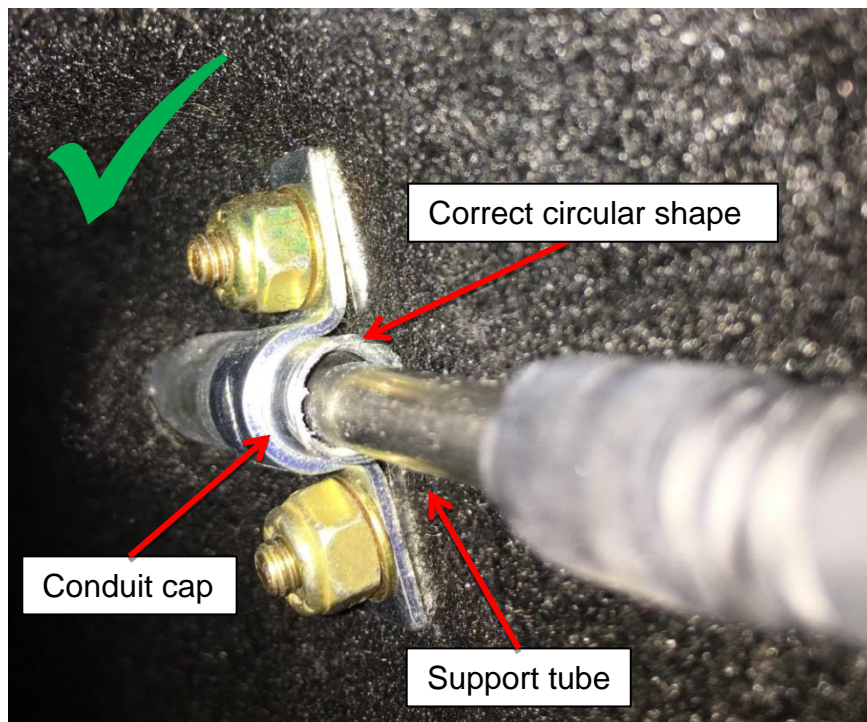
Figure 5 – Inspection of tube mouth

- 2) Inspect the mouth of the tube for distortions such as flattening and non-circular shapes.
