Jabiru Service Letter: Valve Spring Washer Adverse Wear			JABIRU AIRCRAFT PTY LTD P.O. Box 5186 Bundaberg West Queensland, Australia. Phone:+61 7 4155 1778 Fax:+61 7 4155 2669 Email: info@jabiru.net.au		
JSL 008-1	Release Date: 21st Dec 2012	Effective Date: 21st Dec 2012	Affected Models: All	S/No. Range: All	Page 1 of 5

SERVICE LETTER: JSL 008-1

Subject: Valve Spring Washer Adverse Wear

Affected Models: All Jabiru Engines

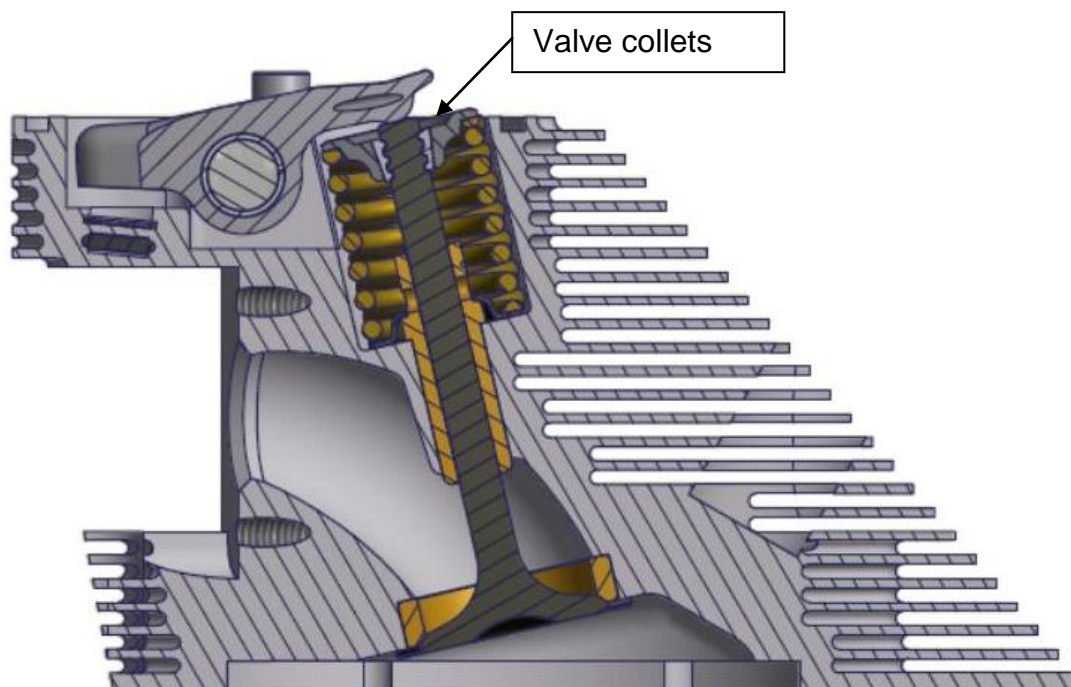
Figure 1 – Valve & Spring Cross Section

- Jabiru Engines use a conventional arrangement of washers and collets to retain the valve spring assemblies (Figure 1).
- By design the valves are free to rotate within the valve collets. The valve actuation mechanism applies a small rotational force to the valve, rotating it to maintain valve sealing.

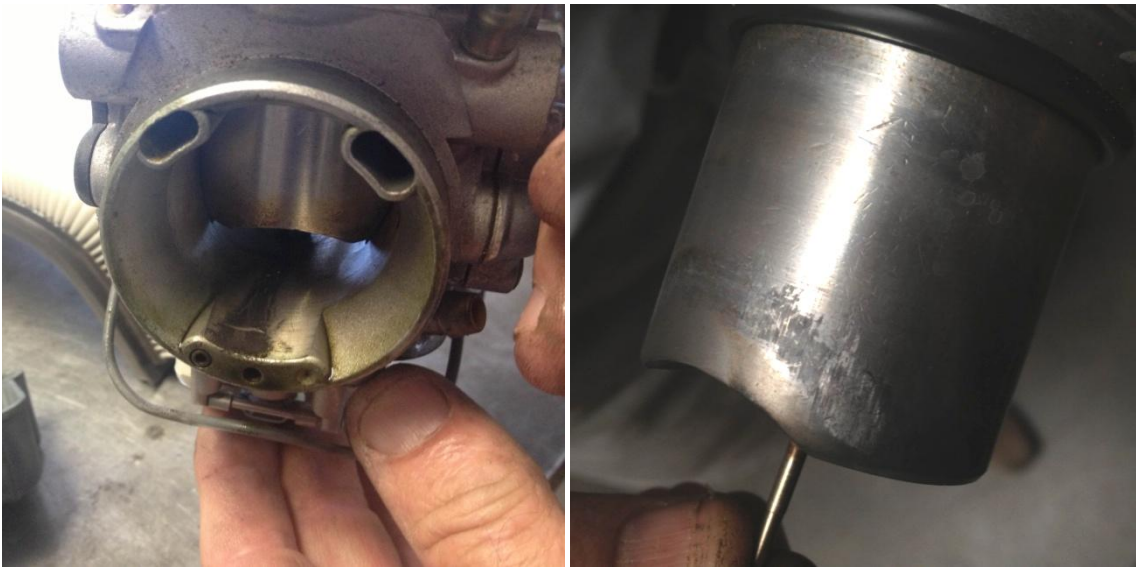
- In both cases the engines were operated in dusty conditions and dirt contamination was found within the carburettor and intake plenum.
- It is likely that dirt contamination caused the valve to jam in its collets.

Figure 3 – Carburettor Contamination & Slide Wear

- Air filters must be cleaned and replaced more frequently.
 - Maintainers must regularly check carburettor bowls, intake piping, oil breathers etc to monitor any potential dust contamination.
