SERVICE BULLETIN: JSB 041-1

Issue: 1
Release Date: 13th July 2017
Effective Date: 20th July 2017
Subject: Jabiru Elevator Cable

Affected Models: All aircraft

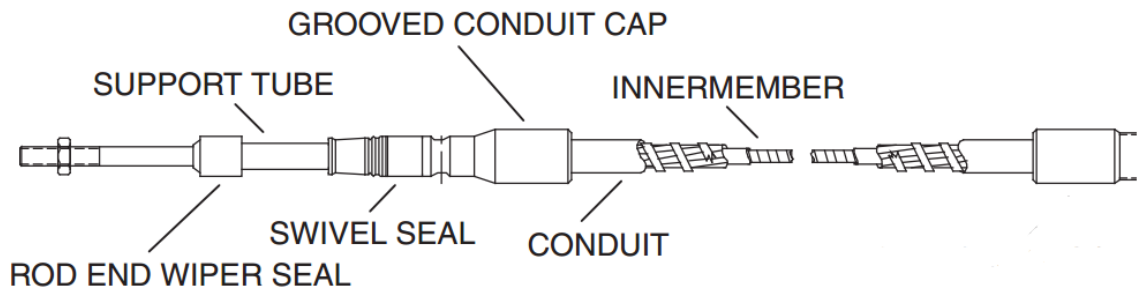
Figure 1 – Elevator cable layout

- Jabiru elevator cables are a Teleflex “push-pull” design with a guide tube attached to prevent buckling of the cable under compression. The support tube end is flared and fits into the grooved conduit cap which has a bowed-in mouth to form a ball-and-socket type attachment with small amounts of free play. Refer to Figure 1 for correct terminology.

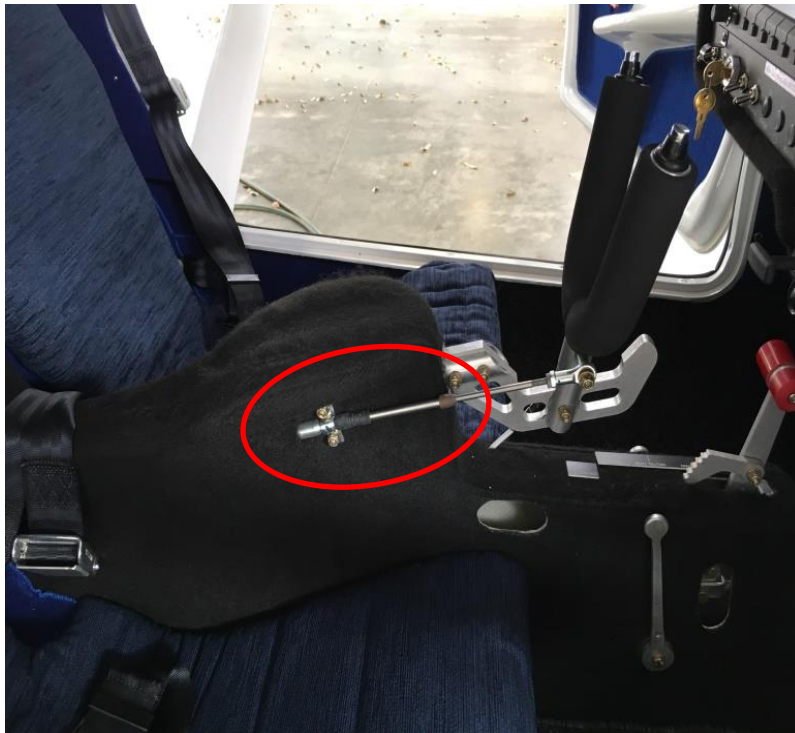
Figure 3 – Location of cables to inspect

The inspection detailed in this section is to be carried out **before the next flight for applicable aircraft** and at the service intervals prescribed in section 3.

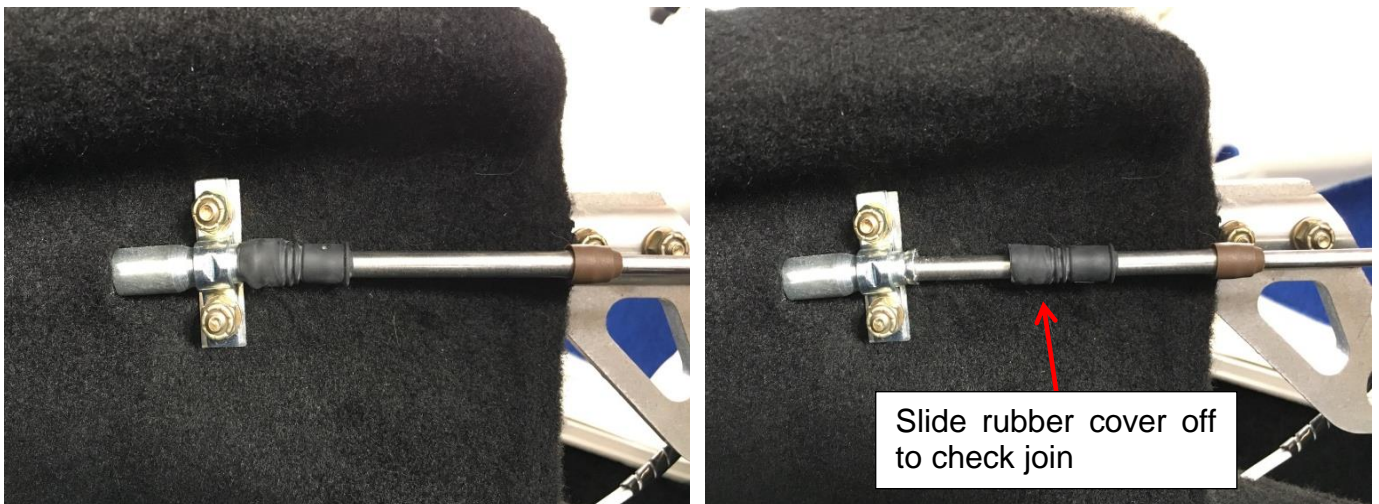
Figure 4 – Pull back rubber cover to inspect tube mouth

- 1) Pull the swivel seal up the support tube to reveal the attachment point with the conduit cap. For aircraft models where this cable is inside the console proceed to step 3 below.

If it is found that the mouth of the conduit cap is significantly distorted and non-circular or that the support tube detaches from the conduit cap joint, the condition must be corrected **before further flight**. Contact Jabiru Aircraft if this situation is encountered and complete a Continued Operating Safety Reporting Form that can be found at the following web address:
